U.S. DEPARTMENT OF COMMERCE
National Oceanic and Atmospheric Administration
NATIONAL WEATHER SERVICE ALASKA REGION
222 West 7th Avenue, #23
Anchorage, Alaska 99513-7575

Mendenhall River Flooding, August 5, 2023

Aaron Jacobs, Senior Service Hydrologist, NWS Juneau Weather Forecast Office

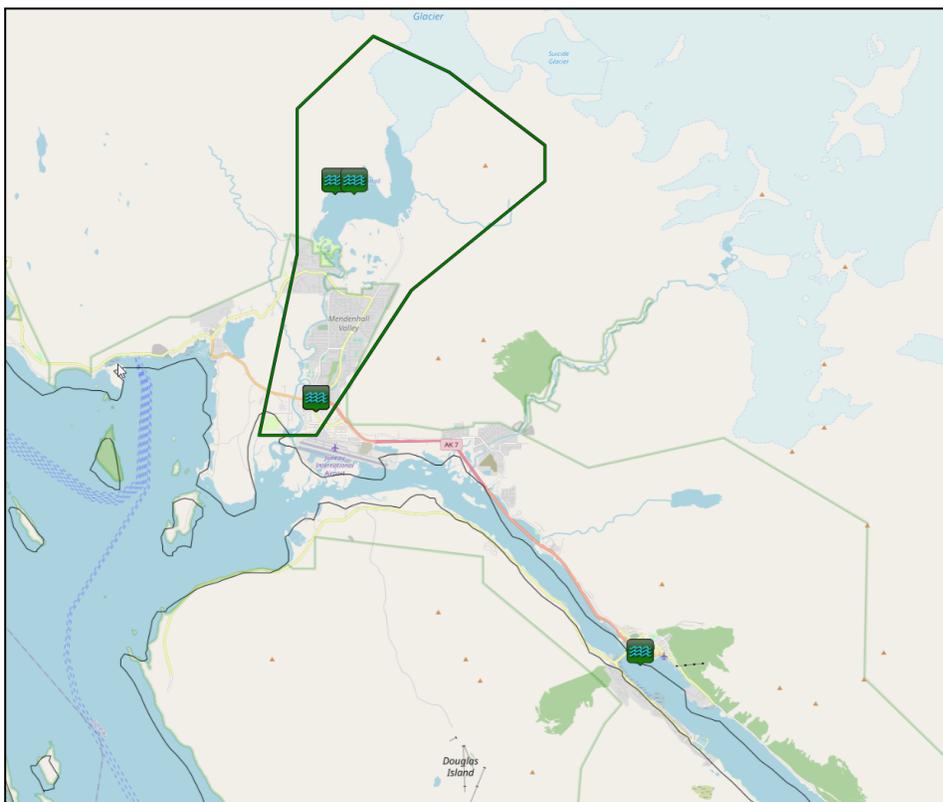
The map below contains all of the Local Storm Reports gathered by NWS Offices during this event. For more detailed information, you can view them individually [here](#).

Image 2: Storm Reports from August 5-6, 2023 (

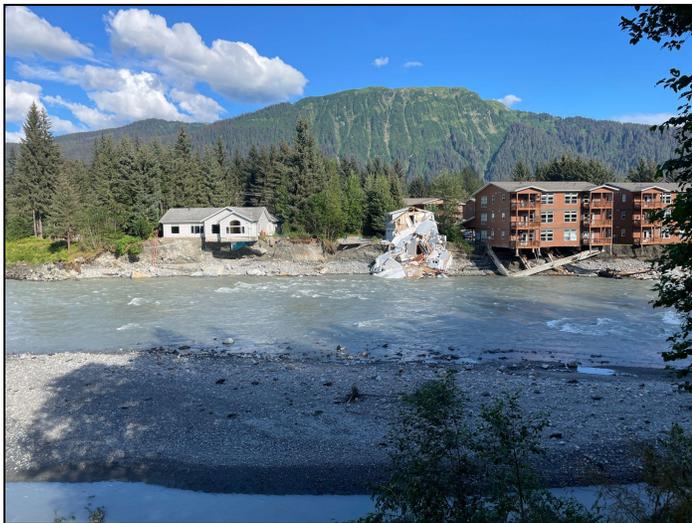
Image 3: Mendenhall River looking at Riverside Condos, a house that fell into the river, and a major damaged house from 4489 River Road

- At 7:58 PM Saturday, August 5th reports of houses flooded and fuel leak on View Drive. Several houses are getting undercut and collapsing into the river at Riverside near Riverside Condos. At least one house started to collapse into the river.

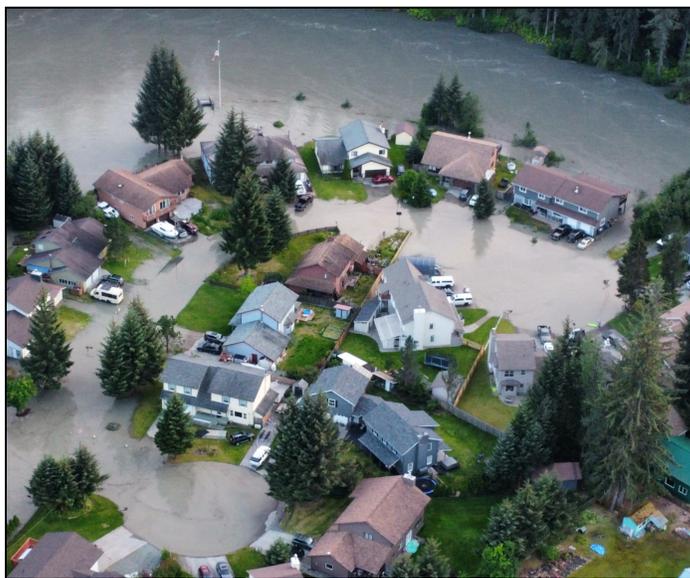
Image 4: 9 PM Aug 5 Meander Way in Juneau

- At 10 PM Saturday, August 5th reports of 1 foot of water in homes along and around Meander Way and other locations in the Mendenhall Valley.

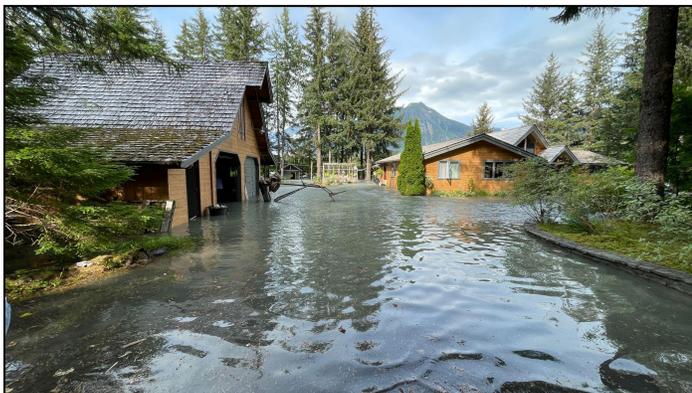
Image 5: Homes along View Drive.

- At 2 PM Saturday, August 5th reports of significant flooding along View Drive with the road cut off with feet of water. People were getting across with boats to help neighbors get things to higher ground along with one house at the end of the road trying to dewater the house with pumps. There were also smells of a fuel spill.

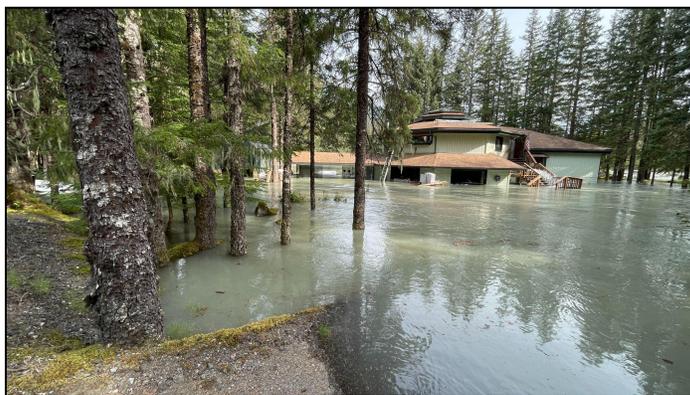
Image 6: Last home along View Drive with 7 feet of water in a home.
